**NARRATIVE REPORT  
ALBANY COUNTRY CLUB**

**TRAFFIC REPORT**

**RE: Trip Generation and Access Assessment, Albany Country Club Subdivision, Town of Guilderland, Village of Voorheesville, Albany County, New York; CM Project 120-226**

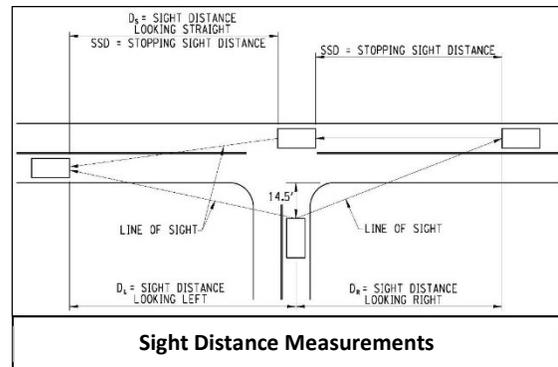
*Stopping* sight distance was also measured on Wormer Road at the proposed access road locations. Stopping sight distance is the length of the roadway ahead that is visible to the driver. The available stopping sight distance on a roadway should be of sufficient length to enable a vehicle traveling at or near the operating speed to stop before reaching a stationary object in its path. The diagram illustrates these sight distance measurements.

A sight distance evaluation was completed at the proposed access road intersections with Wormer Road. Available *intersection* sight distance was measured from the perspective of a passenger car exiting the access roads onto Wormer Road. It was also measured for a passenger car traveling northbound and southbound along Wormer Road looking straight ahead to turn left into the access roads. The available intersection sight distance should provide drivers a sufficient view of the intersecting roadway to allow passenger cars to enter or exit the intersection without excessively slowing vehicles traveling at or near the operating speed on the intersecting mainline.

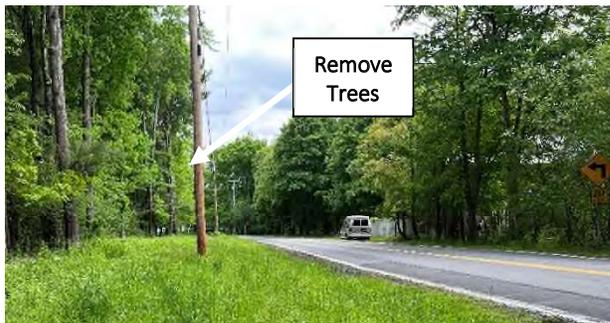
Photo #1 – Access Road #1 Looking Left

- Wormer Road/Access Road #1 – The available intersection sight distance for vehicles turning left into the site from Wormer Road as well as the stopping sight distance for vehicles traveling northbound and southbound on Wormer Road meet AASHTO guidelines for the applicable operating speed. It is noted that available sight distance looking left to make a left or right turn onto Wormer Road is limited by trees located on the east side of the road as shown on Photo #1; however, the assessment indicates that the available sight distance looking left will meet all AASHTO guidelines if this vegetation is removed along the project frontage. In addition, the available sight distance looking right to make a left-turn onto Wormer Road is limited by a vertical curve on Wormer Road north of the Access Road location as shown on Photo #2.

- The sight distance assessment recommends the following improvements:
  - Access Road #1 – Remove trees located on the east side of the road along the property frontage.

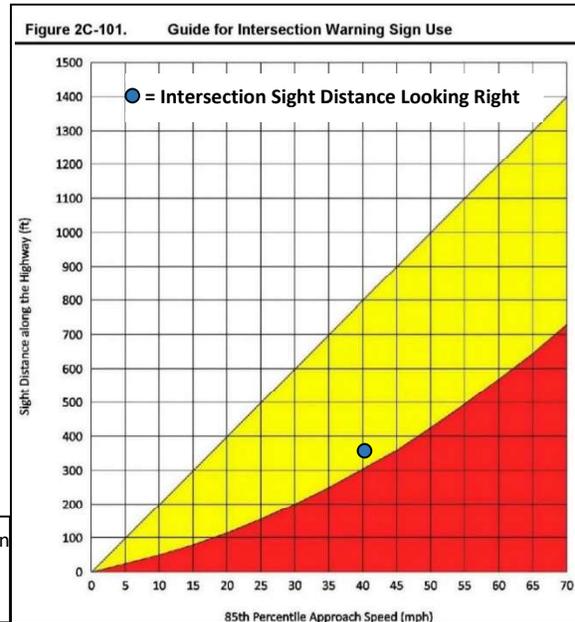
Reference: NYS Supplement to the Manual on Uniform Traffic Control Devices for Streets and Highways (2009 Edition), page 119

Figure 2C-101 found in the New York State Supplement (NYS Supplement) to the National Manual for Uniform Traffic Control Devices (NMUTCD) provides guidance for the installation of “Intersection Warning” signs as mitigation for sight distance. A review of Figure 2C-101 (see figure to the right) indicates that the available sight distance looking right at the Access Road #1 is less than desirable, but not critically limited for a 40-mph operating speed. An “Intersection Warning” is not recommended at this location.

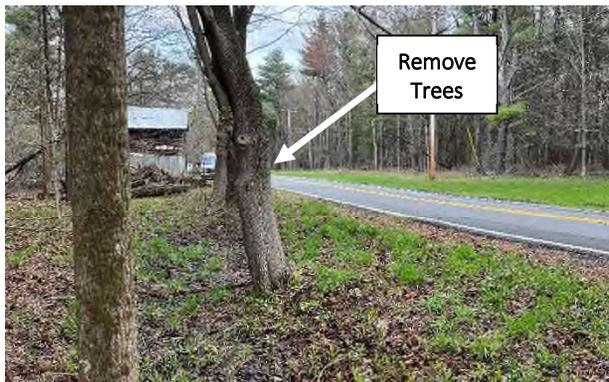
Photo #3 – Access Road #2 Looking Left

- Wormer Road/Access Road #2 – The available intersection sight distance for vehicles turning left into the site from Wormer Road as well as the stopping sight distance for vehicles traveling northbound and southbound on Wormer Road meet AASHTO guidelines for the applicable operating speed. It is noted that the available sight distance looking left to make a left or right turn onto Wormer Road is limited by tress located on the west side of the road as shown on Photo #3. In addition, the available sight distance looking right to make a left-turn onto Wormer Road is limited by vegetation located on the east side of the road as shown on Photo #4. The assessment indicates that the available sight distance will meet all AASHTO guidelines if this vegetation is removed along the project frontage.

- Access Road #2 – Remove trees located on the west side of the road adjacent to the access road and on the east side of the road along the property frontage.

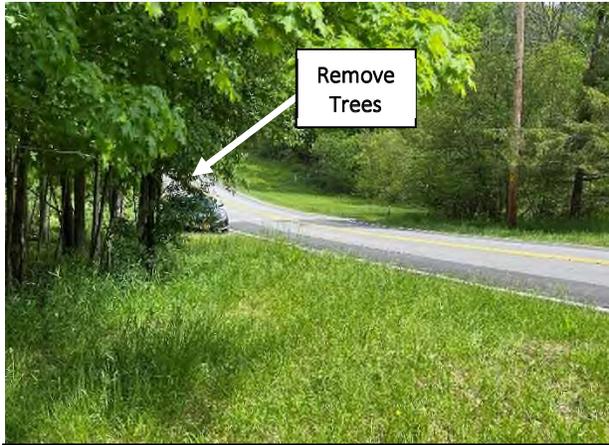
Photo #5 – Access Road #3 Looking Left

- Wormer Road/Access Road #3 – The available intersection sight distance for vehicles turning left into the site from Wormer Road as well as the stopping sight distance for vehicles traveling northbound and southbound on Wormer Road meet AASHTO guidelines for the applicable operating speed. It is noted that available sight distance looking left to make a left or right turn onto Wormer Road and looking right to make a left-turn onto Wormer Road is limited by tress located on the east side of the road as shown on Photo #5 and Photo #6. The assessment indicates that the available sight distance will meet all AASHTO guidelines if this vegetation is removed along the project frontage.

- Access Road #3 – Remove trees located on the east side of the road along the property frontage.
  - Access Road #4 – Regrade the embankment located along the site frontage.

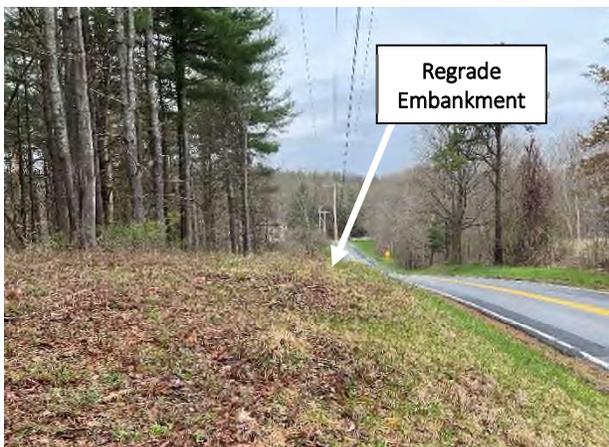
Photo #7 – Access Road #4 Looking Left

- Wormer Road/Access Road #4 – The available intersection sight distance for vehicles turning left into the site from Wormer Road as well as the stopping sight distance for vehicles traveling northbound and southbound on Wormer Road meet AASHTO guidelines for the applicable operating speed. It is noted that available sight distance looking left to make a left or right turn onto Wormer Road and the available sight distance looking right to make a left-turn onto Wormer Road is limited by an embankment located along the site frontage as shown on Photo #7 and Photo #8. The assessment indicates that the available sight distance will meet all AASHTO guidelines if the embankment is regraded along the project frontage.

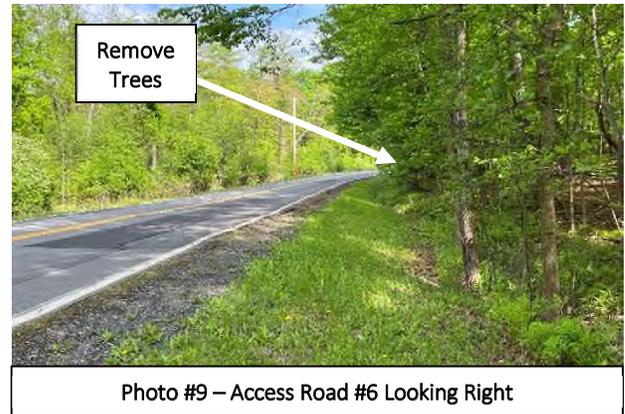
- Womer Road/Access Road #5 – The available intersection sight distance for vehicles turning left and right from the Access Road and turning left into the site from Wormer Road as well as the stopping sight distance for vehicles traveling northbound and southbound on Wormer Road meet AASHTO guidelines for the applicable operating speed. No mitigation is recommended at this site access location.
- Womer Road/Access Road #6 – The available stopping sight distance for vehicles traveling northbound and southbound on Wormer Road meet AASHTO guidelines for the applicable operating speed. In

addition, the available intersection sight distance looking left to make a left or right turn onto Wormer Road and looking straight in order to make a left-turn from Wormer meet AASHTO guidelines for the applicable operating speed. It is noted that available sight distance looking right to make a left-turn onto Wormer Road is limited by trees located on the west side of the road along the site frontage as shown on Photo #9. The assessment indicates that the available sight distance will meet all AASHTO guidelines if this vegetation is removed along the project frontage.

- Access Road #5 – No mitigation.
  - Access Road #6 – Remove trees located on the west side of the road along the property frontage.
  - Access Road #7 – Clear vegetation and maintain sight lines along the frontage.

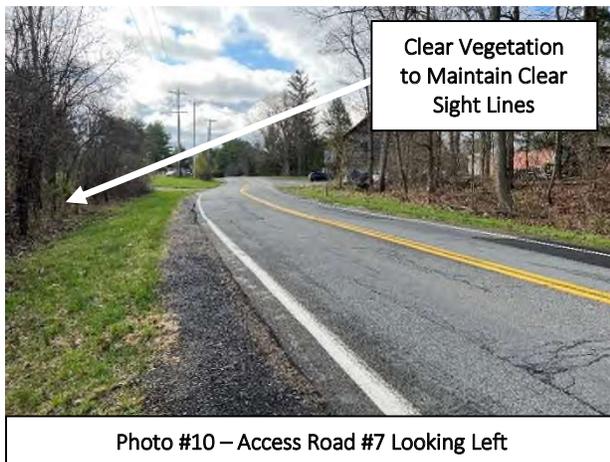
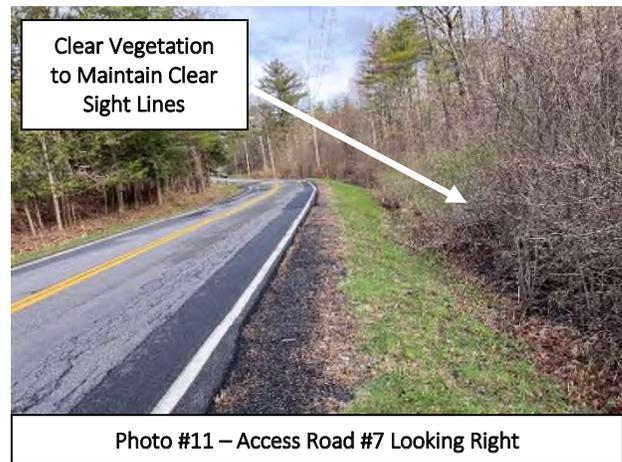
- Womer Road/Access Road #7 – It is noted that the proposed access road on the east side of the road will need to be constructed at-grade due to existing steep embankments. The sight distance assessment indicates that adequate sight lines are provided looking left and right from the access road for vehicles to turn left and right onto Wormer Road or to cross Wormer Road. In addition, the available intersection sight distance looking straight in order to make a left-turn from Wormer Road as well as the stopping sight distance for vehicles traveling northbound and southbound on Wormer Road meet AASHTO guidelines for the applicable operating speed. No mitigation is required at this site access location; however, it is recommended that vegetation located along the site frontage be cleared in order to maintain sight lines as shown on Photo #10 and Photo #11.

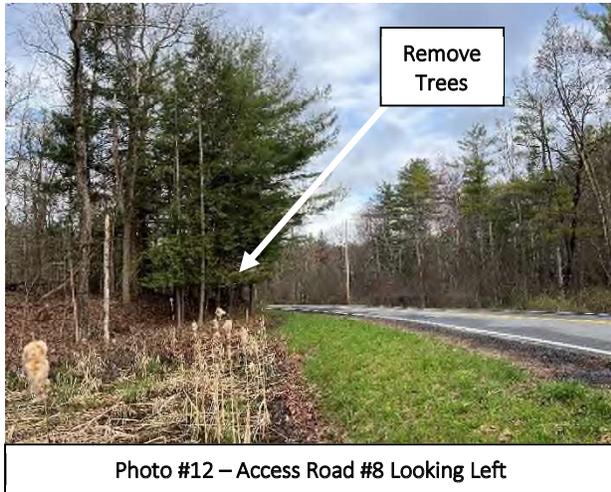
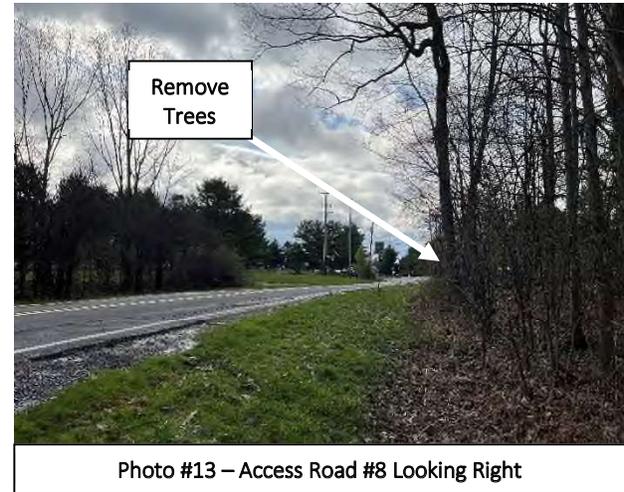
- Womer Road/Access Road #8 – Similar to the access road on the east side of the road, the proposed access road on the west side of the road will also need to be constructed at-grade due to existing steep embankments. The available intersection sight distance for vehicles turning left into the site from Wormer Road as well as the stopping sight distance for vehicles traveling northbound and southbound on Wormer Road meet AASHTO guidelines for the applicable operating speed. It is noted that the available sight distance looking left to make a left or right turn onto Wormer Road and looking right to make a left-turn onto Wormer Road is limited by trees located on the west side of the road as shown on Photo #12 and Photo #13. The assessment indicates that the available sight distance looking left and right will meet all AASHTO guidelines if this vegetation is removed along the project frontage. It is also noted that adequate site lines will also be provided to cross Wormer Road.

- Access Road #8 – Remove trees along the frontage on the west side of the road.
  - Access Road #9 – No mitigation.
