**NORMANSKILL PROJECT
FERC NO. 2955
Draft
2019 Relicensing Study Report
Water Quality Monitoring**

March 2019

The City of Watervliet, New York

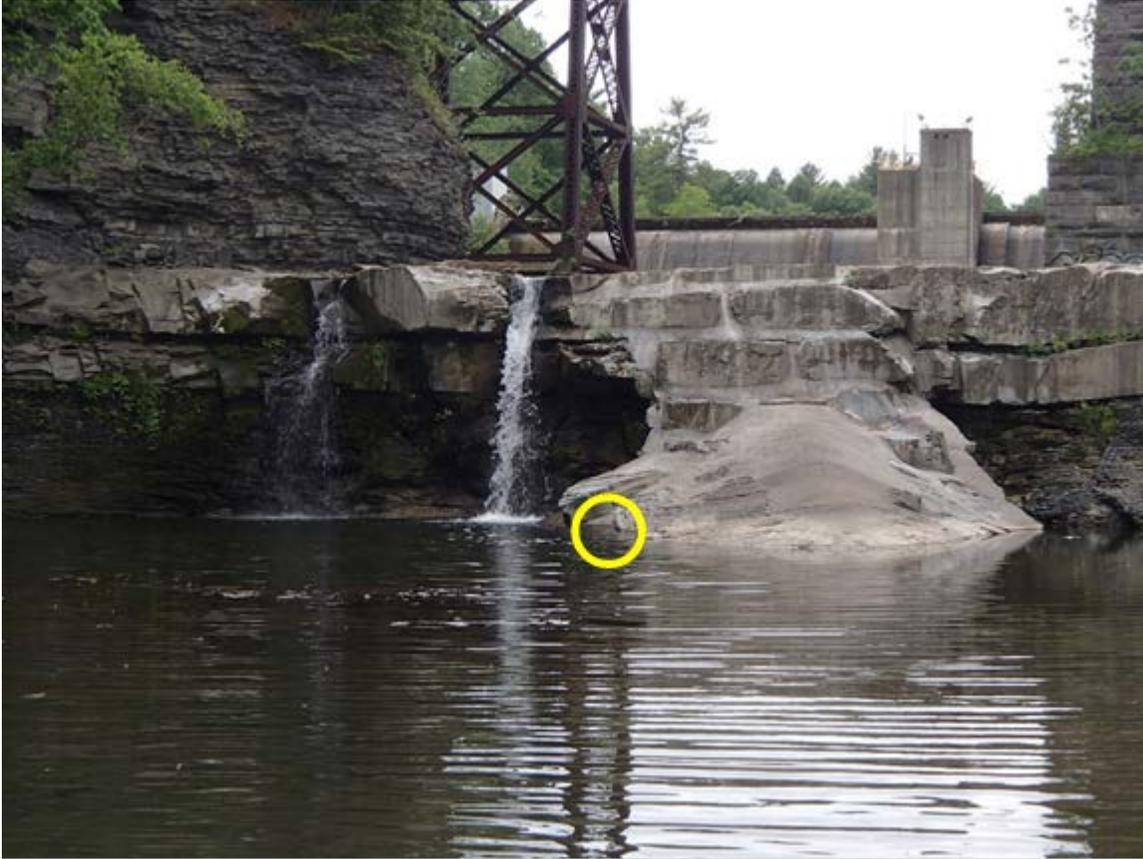
Figure 2.1-2: Photograph of Bypass Monitoring Location 1a

View looking upstream. Logger deployed to the left of the penstock. The yellow circle indicates where the wire rope attached to the cinderblock was tethered to the penstock.

The water quality loggers were attached to cinderblocks which were anchored to the selected locations using wire rope and clamps. Site 1a was initially located in the bypass reach approximately 400 feet downstream of the dam, next to an exposed portion of the penstock. The logger was attached to a cinderblock with wire rope. The cinderblock was attached via additional wire rope to a loop embedded in the concrete covering the penstock. The cinderblock and attached logger were then lowered to the streambed, approximately 4 feet below the water surface. The equipment at Site 1a was vandalized soon after installation, so Site 1b was selected as a replacement. Site 1b was located in the bypass reach upstream of the railroad bridge and approximately 55 feet downstream of the dam. This location was selected for its more challenging accessibility, to minimize the likelihood for further vandalism. The cinderblock was attached to a piece of rebar that was hammered into the stream bed. The depth of the water at this location was approximately 2 feet. Site 2 (Tailrace) was located approximately 300 feet downstream of the project discharge. The cinderblock was attached to a tree on river-right and lowered to the stream bed, approximately 3 feet¹ below the water surface. The names and locations of the water quality loggers are summarized in [Table 2.2-2](#).

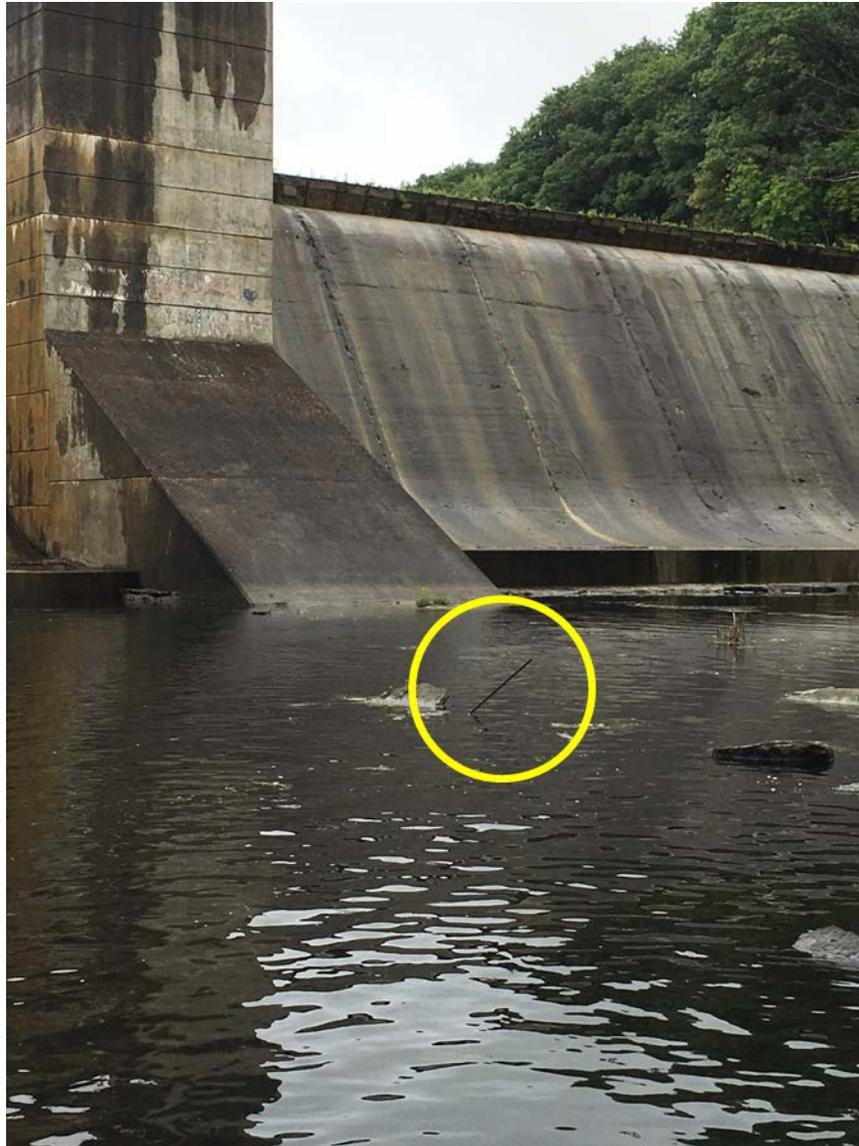
Figure 2.1-3: Photograph of Bypass Monitoring Location 1b

View looking upstream from river-right. Logger deployed approximately 55 feet downstream of the dam. The rebar securing the cinderblock is indicated in the yellow circle.

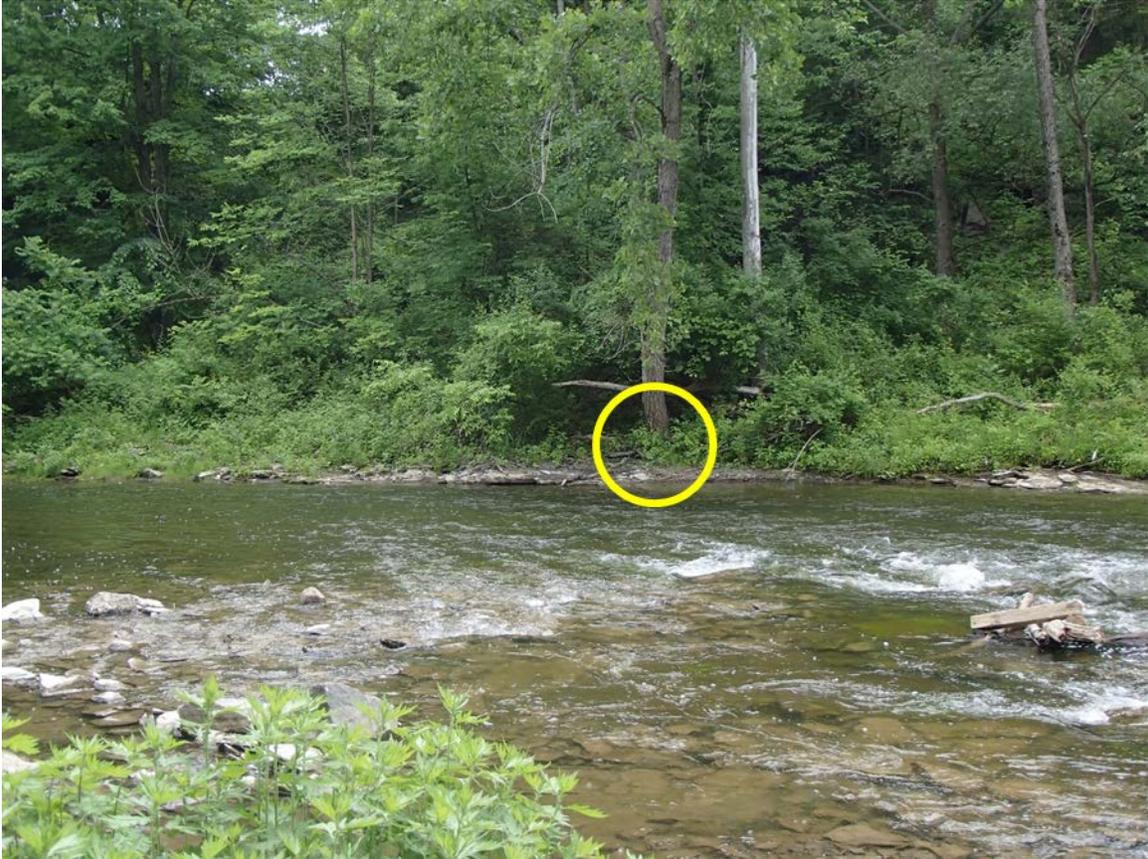
Figure 2.1-4: Photograph of Tailrace Monitoring Location 2

View from river-left. Logger deployed near river-right. The yellow circle indicates where the wire rope attached the cinderblock was tethered to the tree.
